BORON AND UHSS

BORON / UHSS

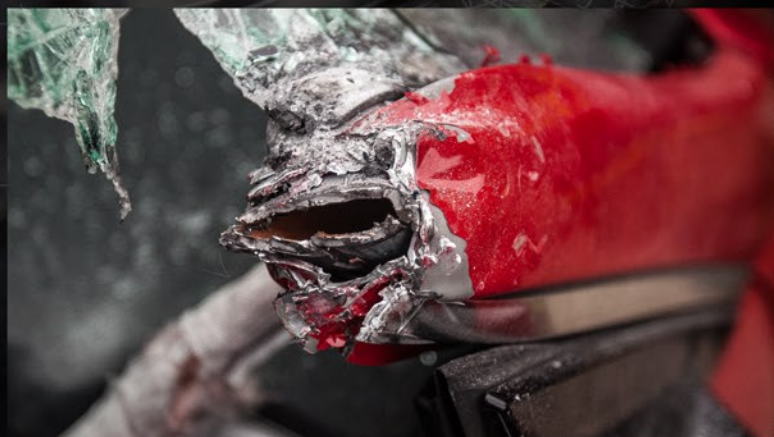
A-Post 2013 Mercedes Benz

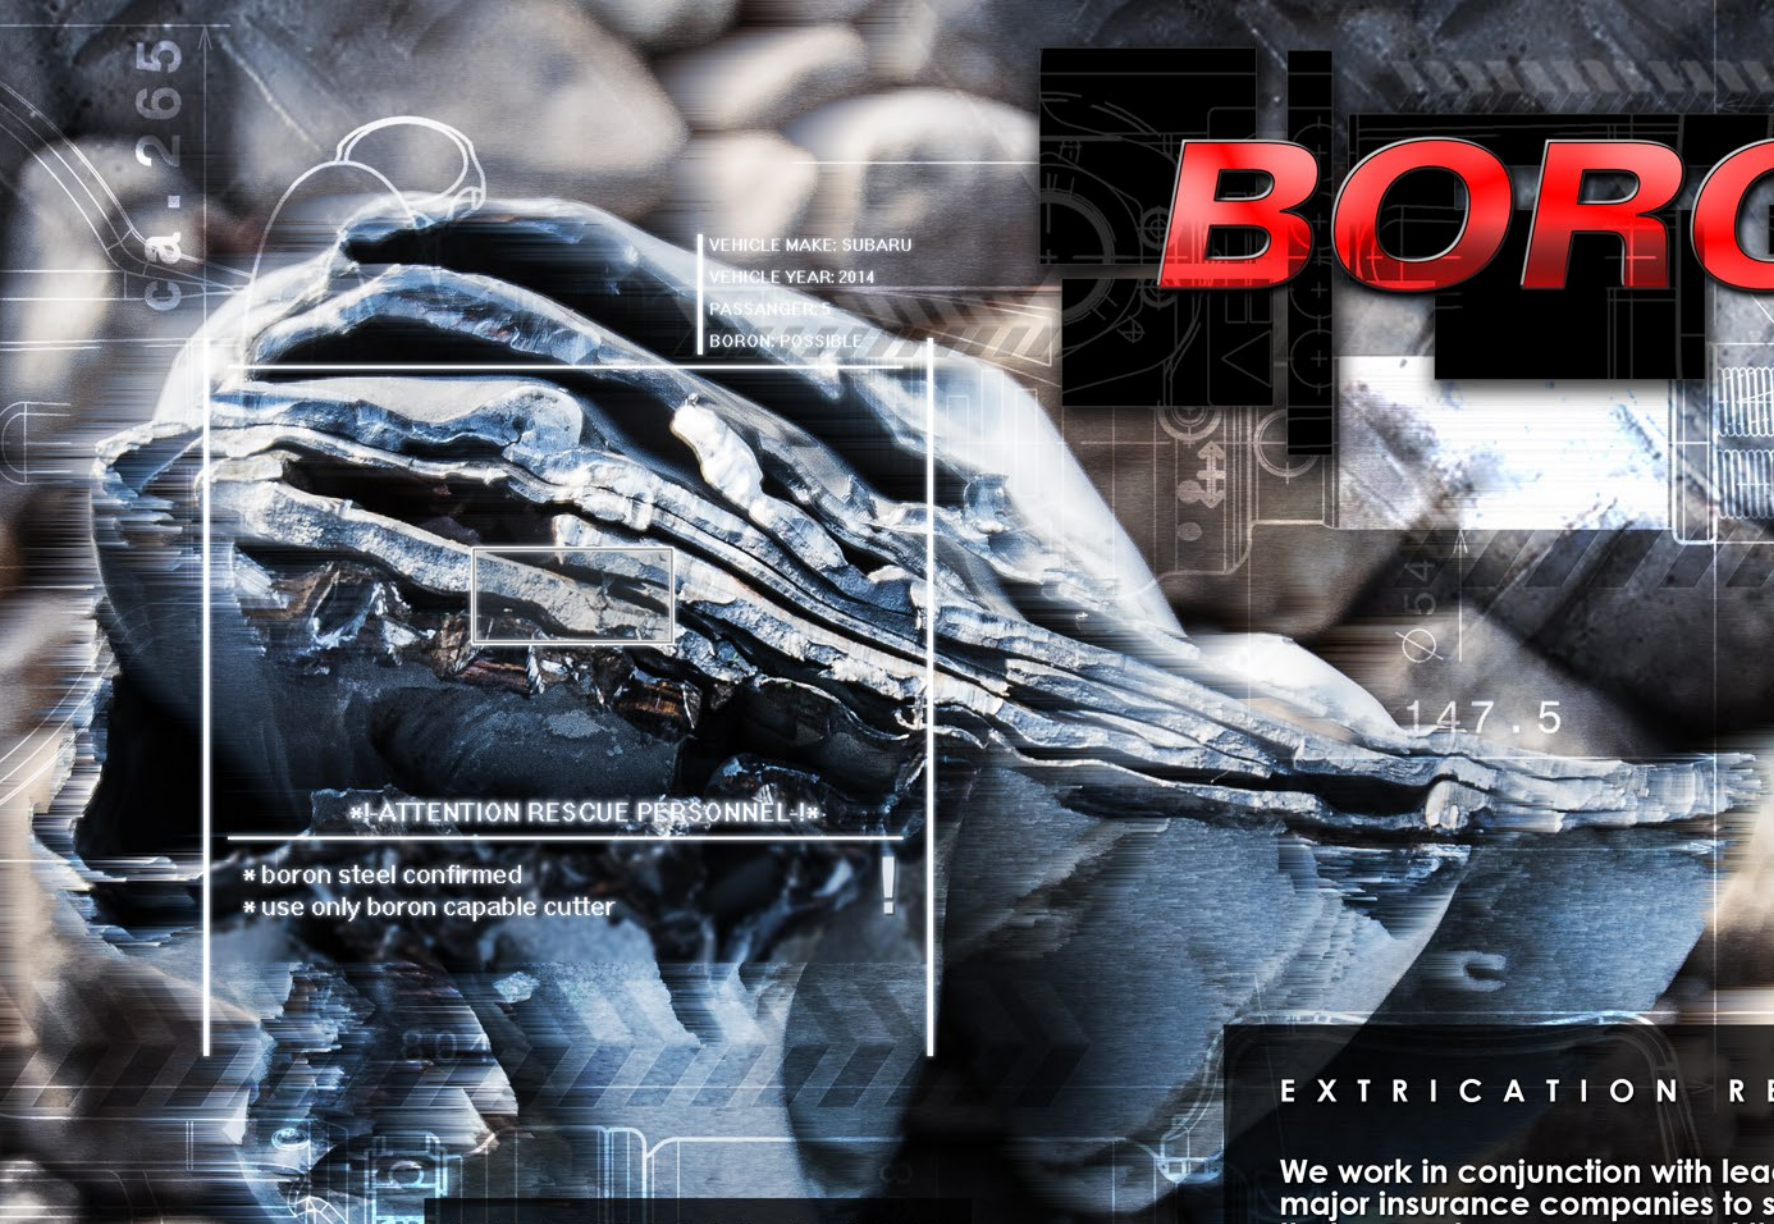
VEHICLE MAKE: SUBARU
VEHICLE YEAR: 2014
PASSENGER
BORON: POSSIBLE

ATTENTION RESCUE PERSONNEL!

- * boron steel confirmed
- * use only boron capable cutter

2014 SUBARU B-POST

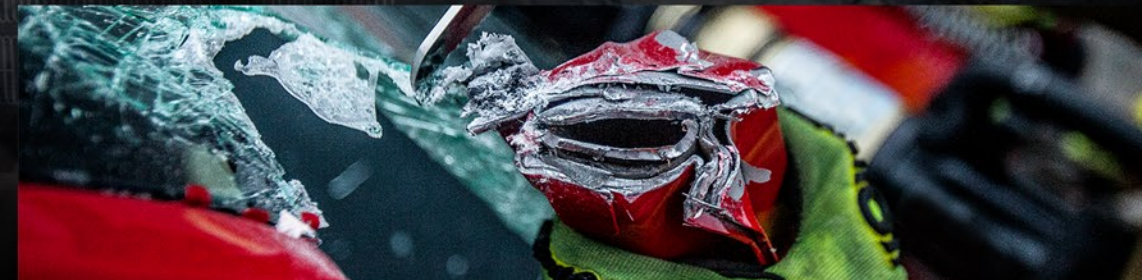
UHSS requires an enormous amount of compression force to cause it to catastrophically crack or shatter. The cutter does not actually cut the UHSS material. UHSS steel has very similar properties to that of glass, as it is extremely hard, but very brittle. As you watch the video you can see this concept by listening for the "crack" of the UHSS bars as they are cut. The enormous amount of pressure it takes to "crack" the bars is where hydraulic cutters don't measure up. All except for the full line of Genesis Boron Capable cutters as is demonstrated by the accompanying video.
